**Repair of Damaged Concrete Structures Using Prepreg Composites**

**(MBTC 2033)**

Guoqiang Li, Ph.D.  
Assistant Professor-Research  
Department of Mechanical Engineering  
Louisiana State University  
Baton Rouge, LA 70803

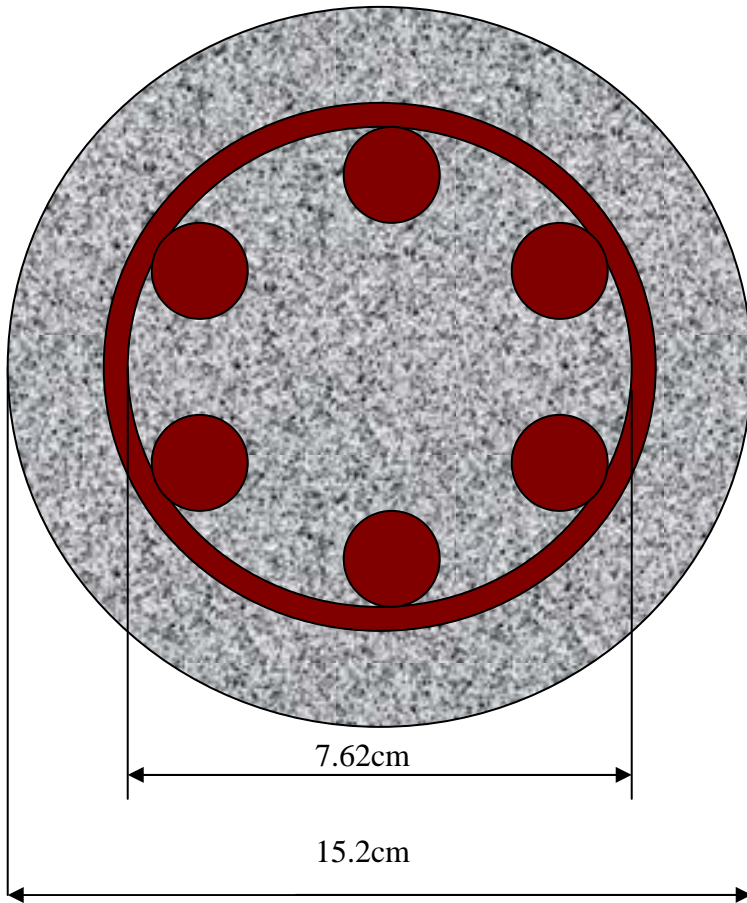
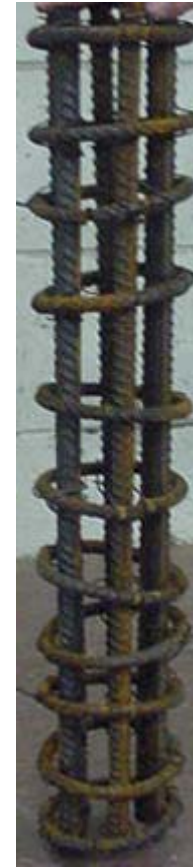
(a) Schematic of cross sectional design of steel reinforcement

(b) Actual steel reinforcement

Figure1 (a) Schematic cross sectional design of steel reinforcement and (b) Actual steel reinforcement

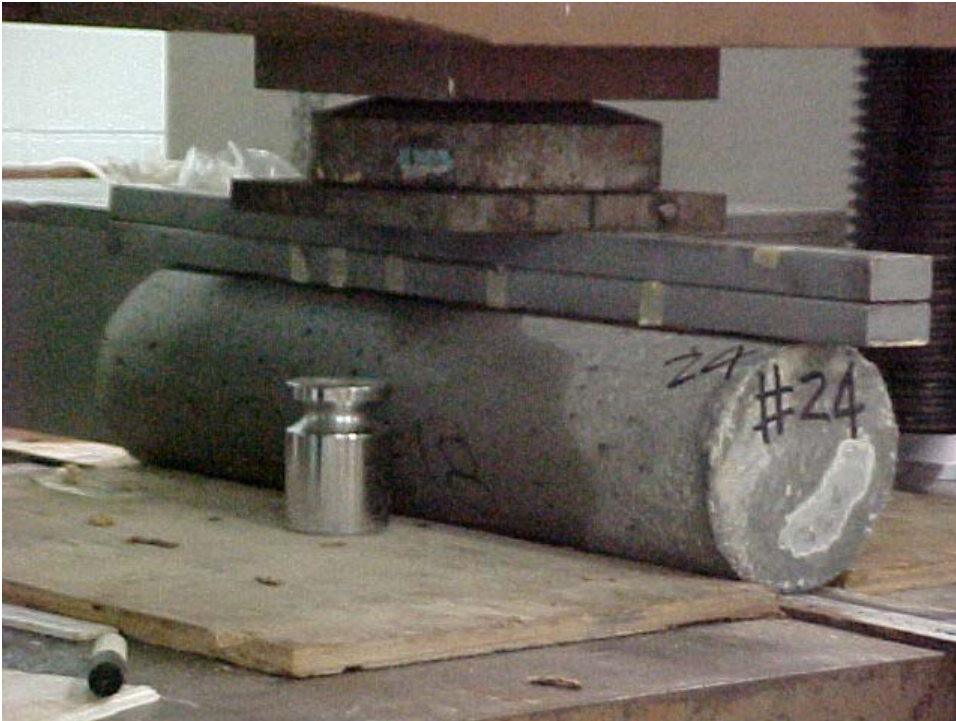
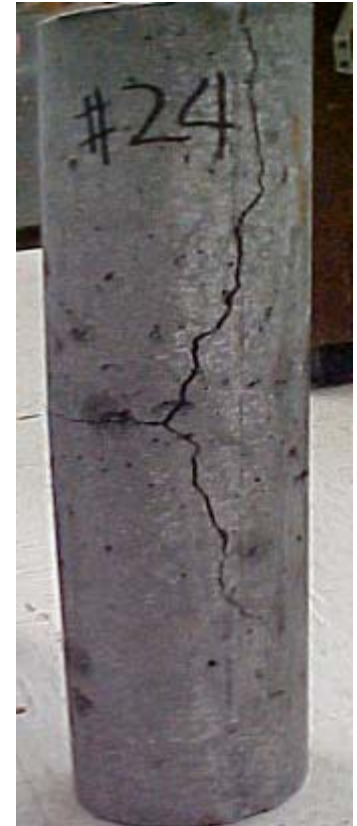
(a) Split tensile test

(b) Induced cracks

Figure 2 (a) Split tensile test and (b) cracks resulting from split tensile test

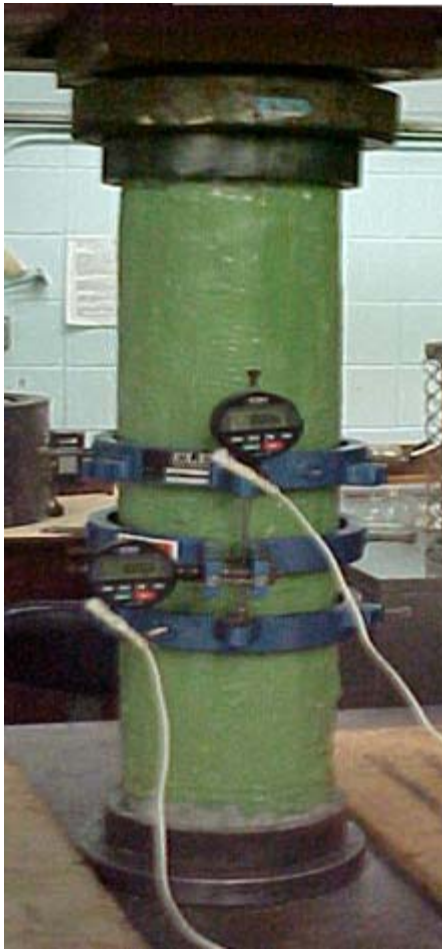
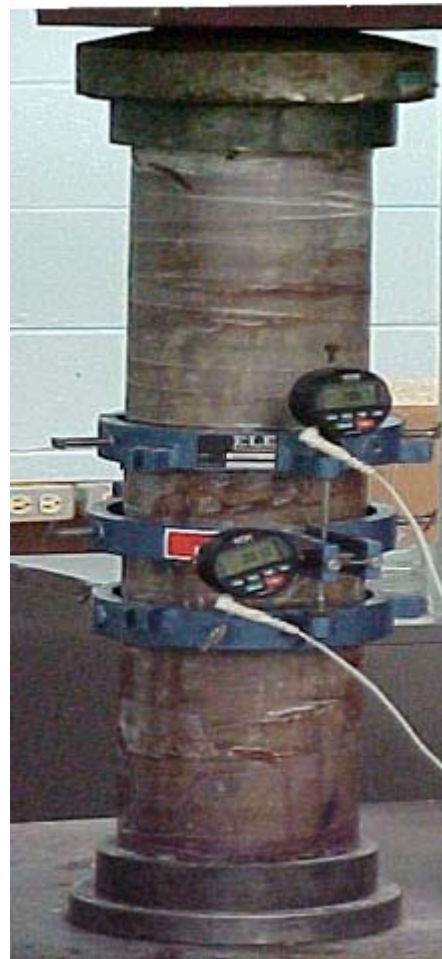
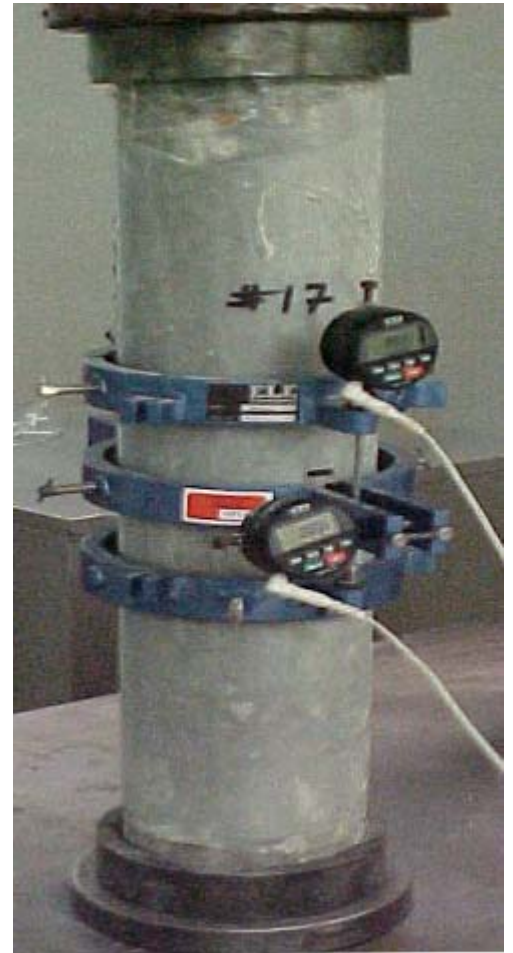
(a) Epoxy repaired sample

(b) Prepreg repaired sample

(c) UV curing resin repaired sample

Figure 3 (a) Epoxy repaired sample in compression test, (b) prepreg repaired sample in compression test, and (c) UV curing resin repaired sample in compression test

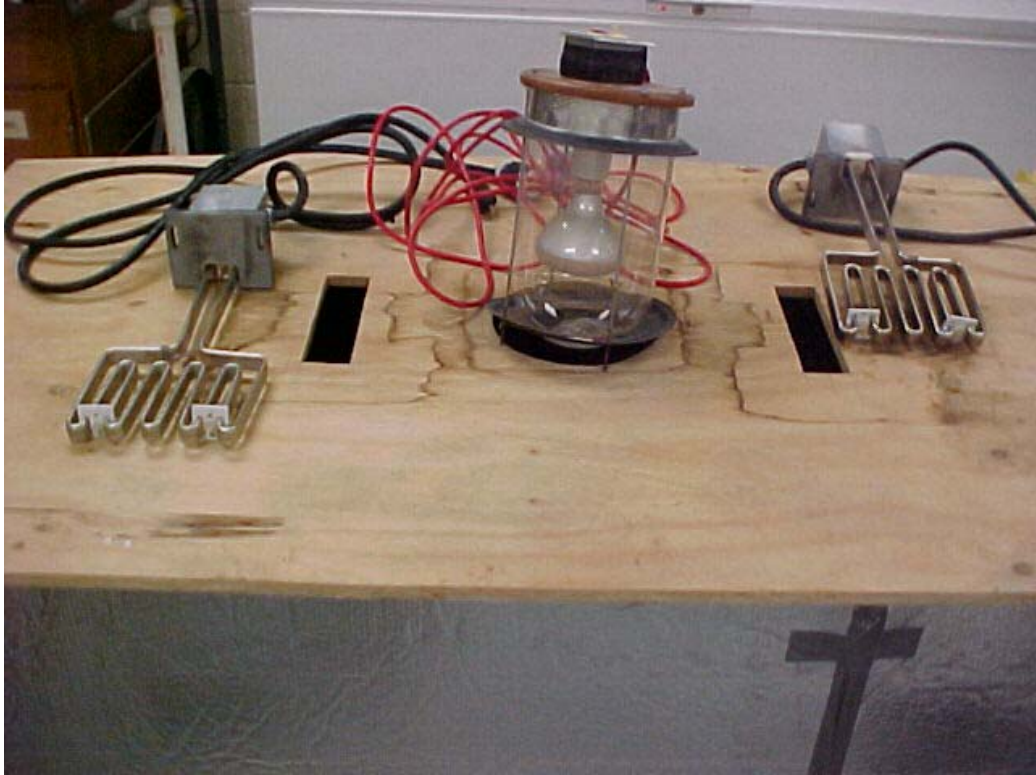
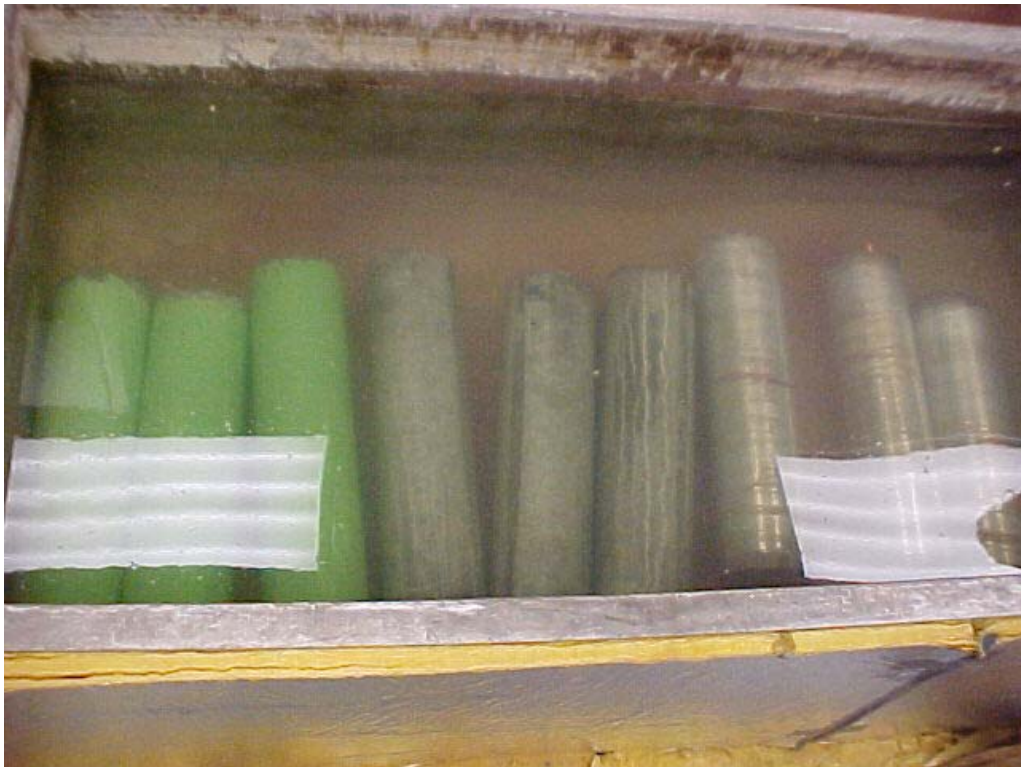
(a) Conditioning tank

(b) Samples in the tank

Figure 4 (a) Conditioning tank with heaters and UV lamp and (b) samples in conditioning tank

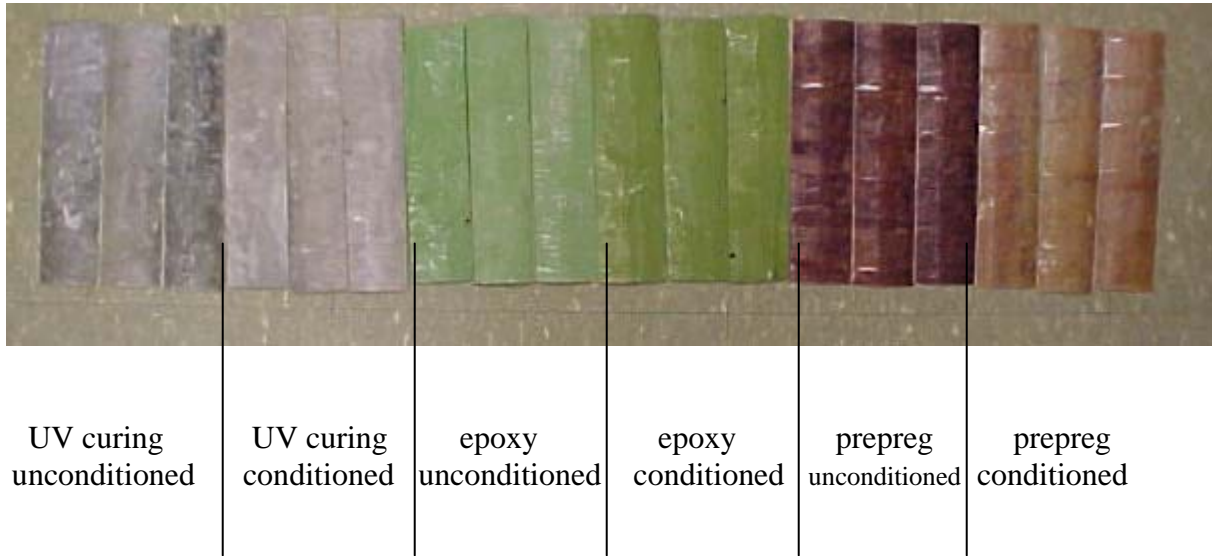
Figure 5 FRP coupons from repaired samples for residual tensile test

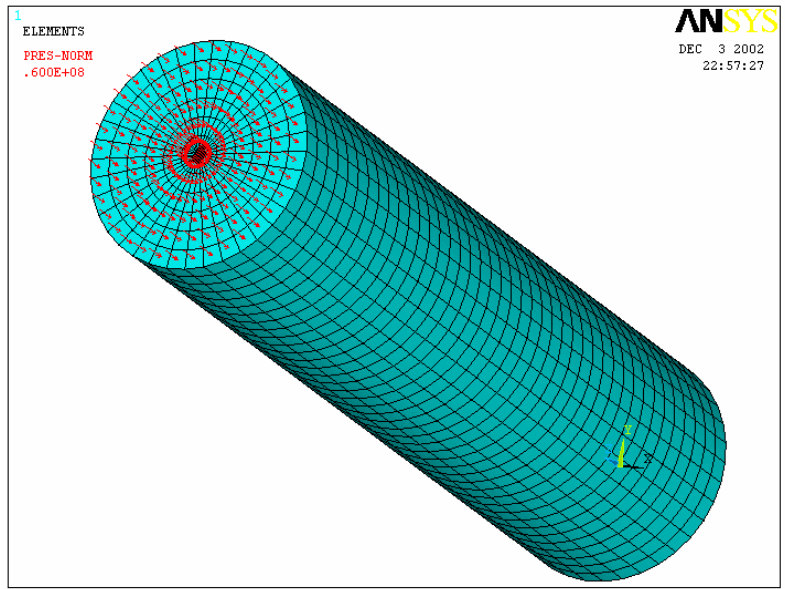
Fig. 6 Three-dimension mesh

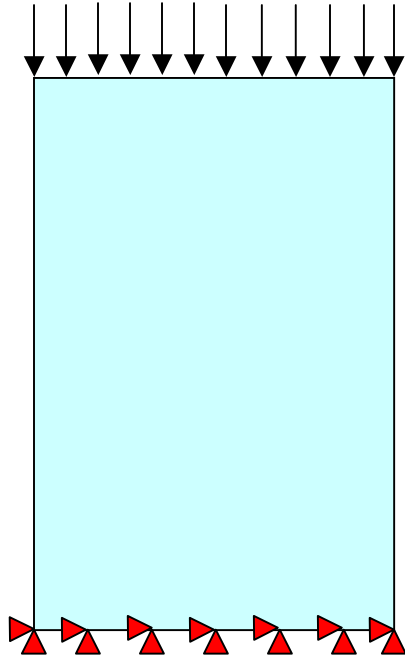
Fig. 7 A schematic of boundary conditions and applied pressure

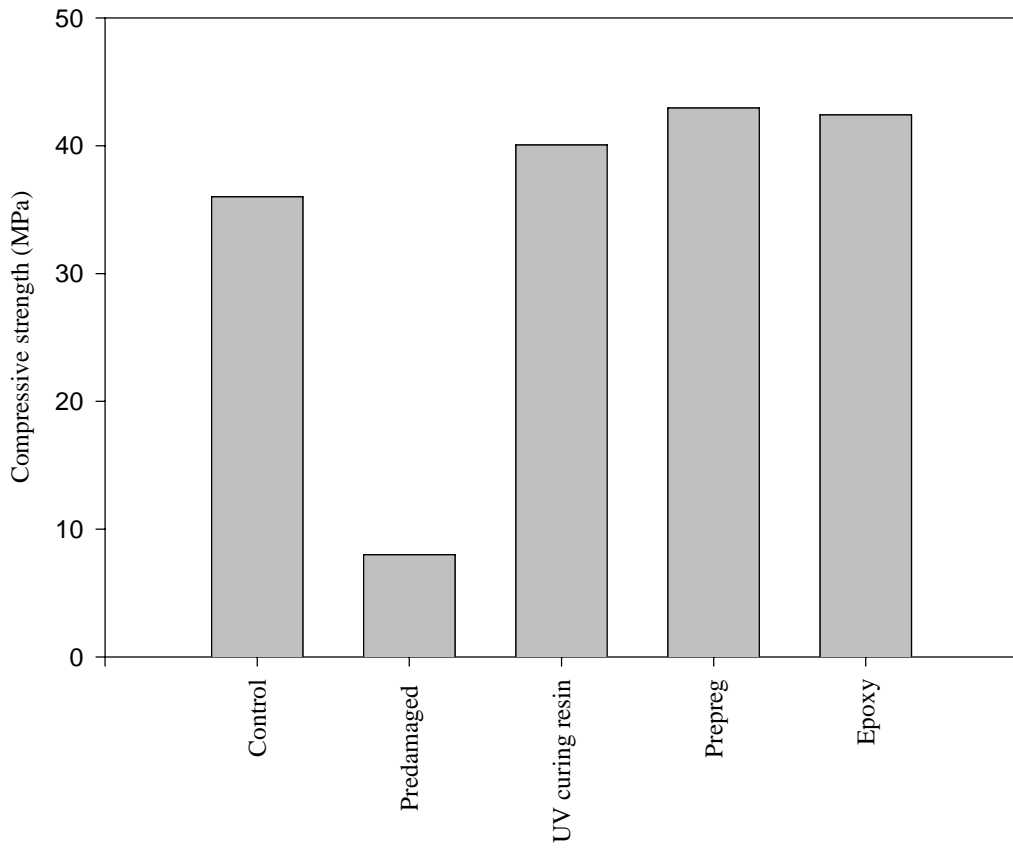
Fig. 8 Averaged compressive strength of various samples without conditioning

The averaged compressive strength and the modulus of elasticity of the various control samples and repaired samples are shown in Figs. 8 – 11, respectively. From Figs. 8 - 11, the following analyses can be conducted.

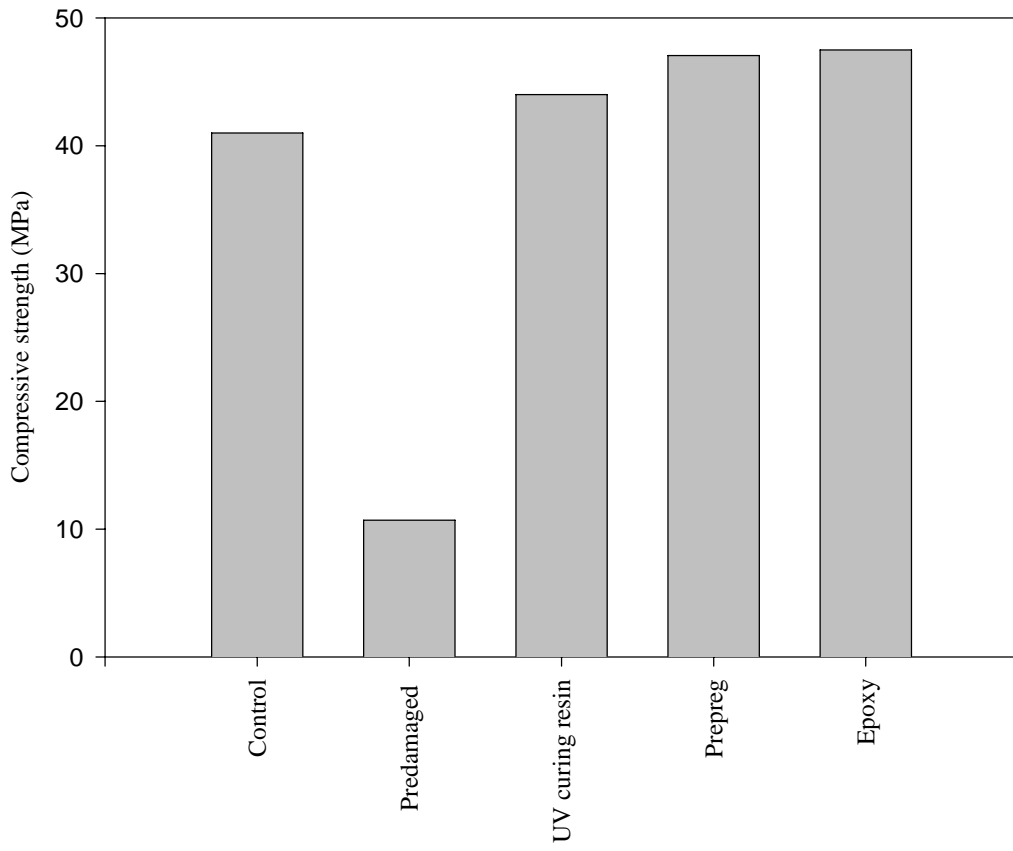
Fig. 9 Averaged compressive strength of various samples with conditioning

Subjected to environmental conditioning, the repairs still considerably increased the compressive strength of the predamaged columns, as shown in Fig. 9. Again, only two layers of FRPs recovered all the lost compressive strength. The compressive strength of the UV curing resin repaired samples was 4.15 times the strength of the predamaged samples. The compressive strength of the prepreg repaired samples was 4.44 times the strength of the predamaged samples. The compressive strength of the epoxy repaired samples was 4.39 times the strength of the predamaged samples. Comparing the reinforcing efficiency in Fig. 9 with that in Fig. 8, it is found that environmental conditioning reduced the reinforcing efficiency of the three FRPs. The reduction of the reinforcing efficiency was 14.6 % for UV curing resin, 17.2 % for heat activated curing prepreg, and 17.2 % for ambient environment curing epoxy. The reason for the reduced reinforcing efficiency is that the FRPs are degraded subjected to environmental conditioning. This can be validated by the residual strength test of the FRP coupons cut from the repaired columns. As shown in Table 5, about 12.5 % of the peak load was lost for the UV curing FRP after conditioning. This number became 15.3 % and 14.9 % for the prepreg and epoxy FRP, respectively.

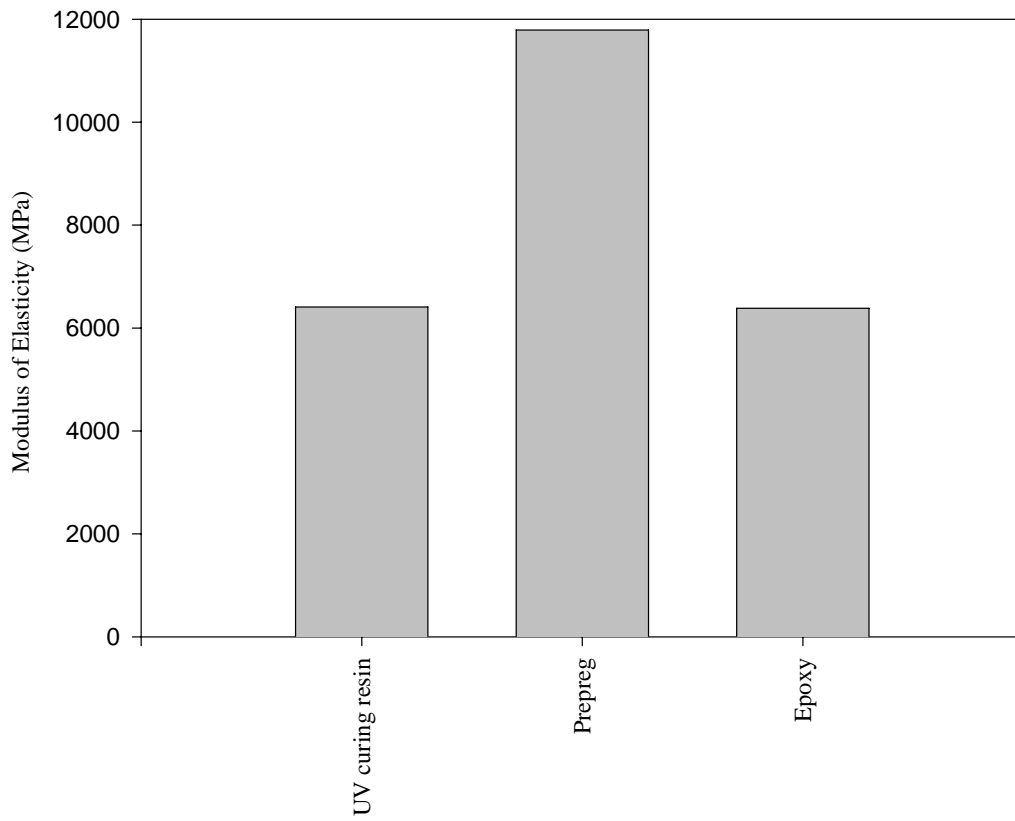
Fig. 10 Averaged modulus of elasticity of repaired samples without conditioning

From Fig. 10, the modulus of elasticity of the prepreg repaired samples was nearly twice that of both the UV curing resin and epoxy repaired samples. This is likely due to a better resin penetration into the cracks and voids of the concrete, as observed in a broken sample shown in Fig. 12. This resin penetration is due to the pressure applied by the shrink tape during the heat activated curing process, resulting in better interfacial bonding. As a result, the stiffness of the prepreg repaired samples was much higher than that of UV curing resin and epoxy repaired samples. It is noted that, however, the good interfacial bonding did not increase the compressive strength considerably. The compressive strength of prepreg repaired samples was only slightly higher than that of the rest repairs, as shown in Fig. 8. This result is in agreement with previous studies in showing that increased interfacial bonding does not significantly increase the compressive strength of a repaired RC column [12]. Even so, a good interfacial bonding is still desirable, particularly for applications where deflection is a limiting factor.

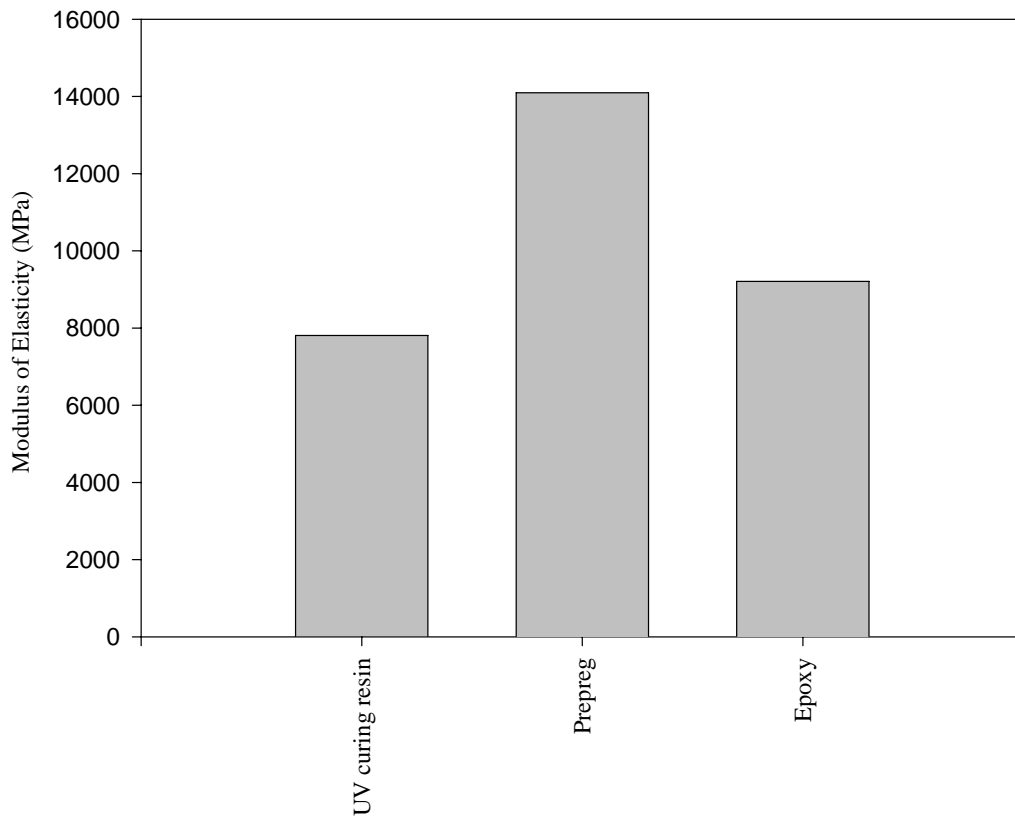
Fig. 11 Averaged modulus of elasticity of repaired samples with conditioning

The modulus of elasticity exhibited the same behavior as with the unconditioned samples. From Fig. 11, prepreg repaired samples had a modulus of elasticity nearly twice as many as the modulus of the UV curing resin and epoxy repaired samples. It is noted that the actual values of the conditioned samples are larger than that of the unconditioned samples. This does not mean the conditioning increased the stiffness of the FRPs. Actually, it decreased the stiffness of the FRPs, as shown in Table 5. The larger stiffness of the repaired samples was a result of the stronger batch of concrete used to cast the conditioned batch.

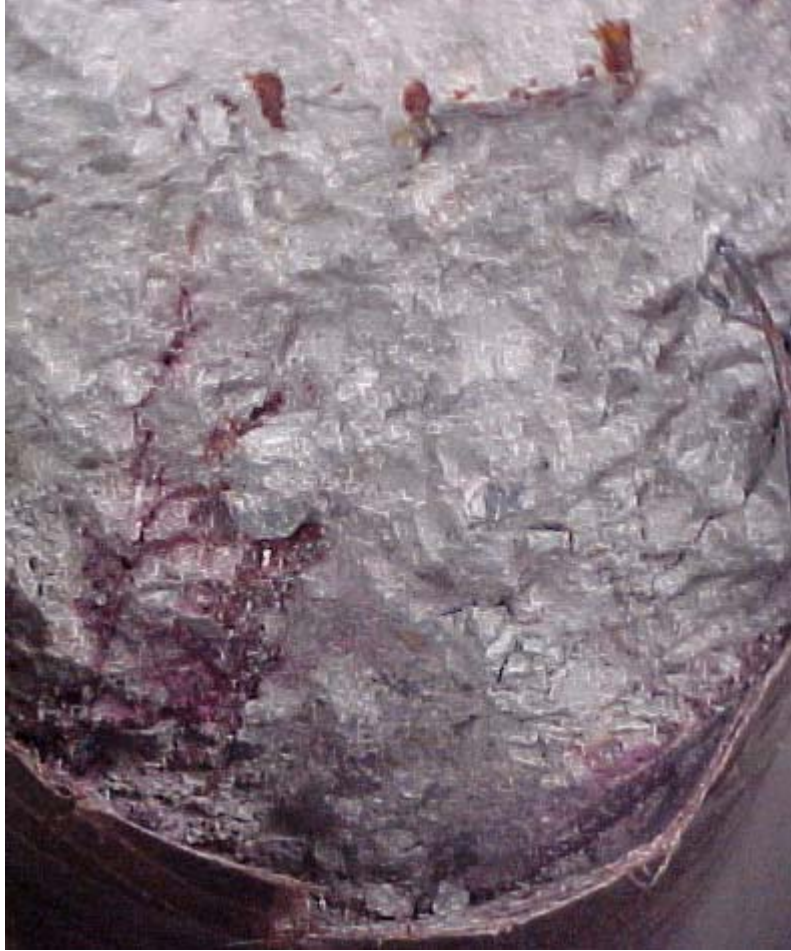
Figure 12 Penetration of resin into cracks from prepreg repaired sample

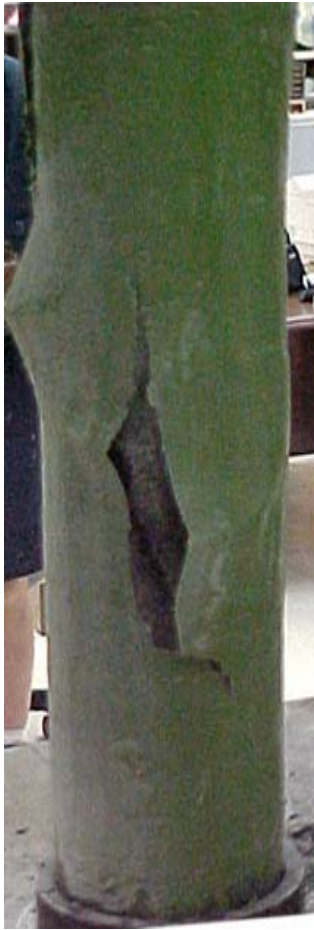
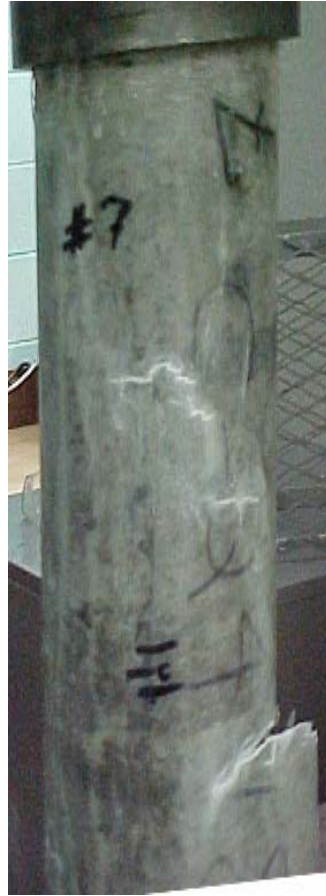
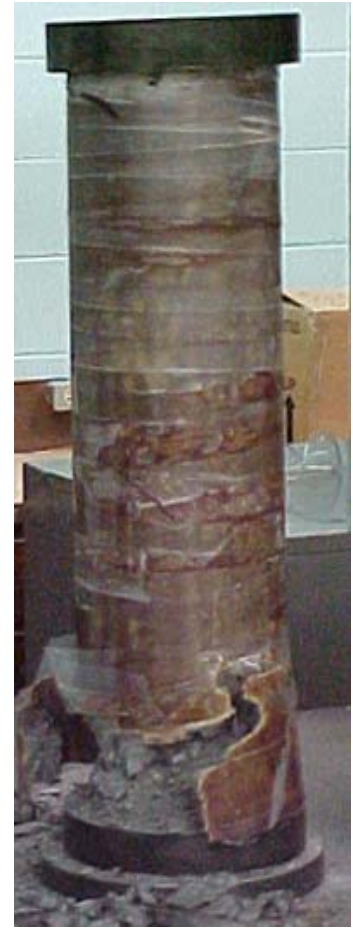
Figure 13 (a) Failure of epoxy repaired sample, (b) Failure of UV curing resin repaired sample, and (c) Failure of prepreg repaired sample

The failure of all the repaired samples was due to the tensile failure of the FRP layers. The failure initiated from about one-eighth to the middle along the height of the columns. Once the crack was initiated, it propagated along the axial direction towards the ends of the sample, as shown in Fig. 13 (a) – (c) with various repairs. Although the failure of the FRPs was a sudden event, the sound from fiber breakage was clearly heard a while before the failure of the FRPs, an indication of warning. After the failure of the FRPs, the broken surface was very rough, a symbol of good fiber/matrix interfacial bonding. In addition, no debonding was observed between the two FRP layers. This means the FRP was well laminated and the construction techniques used in this study were applicable. Furthermore, it was observed that a thin layer of concrete was attached to the FRP layers after failure. This means the three resins had a good bonding with the concrete. They were chemically compatible with concrete. With FRP confinement, only the concrete within the FRP broken zone was disintegrated. The majority of the column was still in an integrated shape.

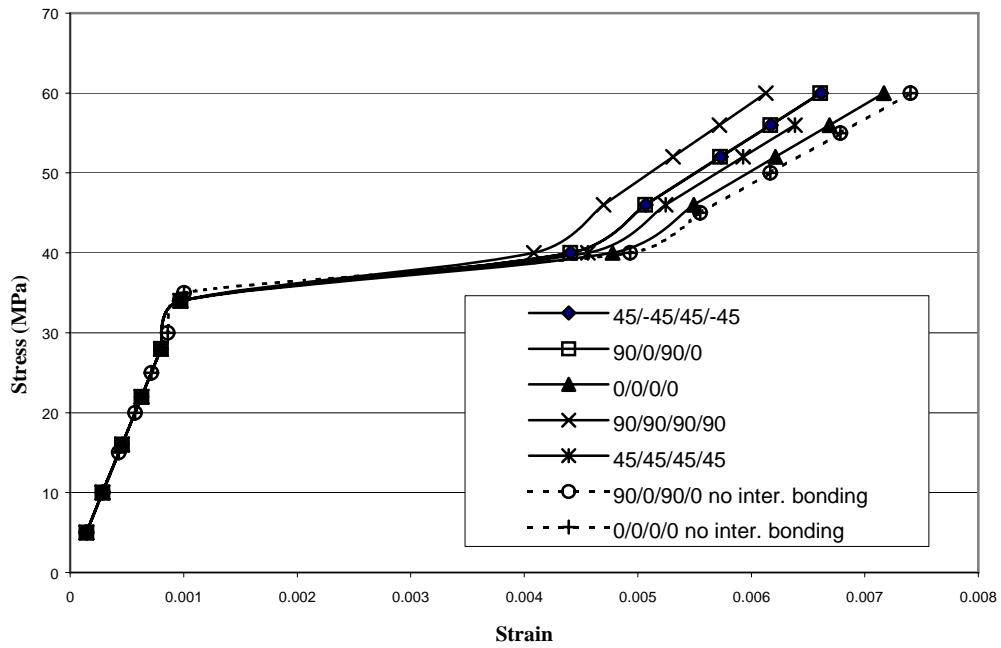
Fig. 14 Effect of fiber orientation on the stress-strain behavior

Figure 14 shows the effect of fiber orientation on the stress-strain curves. It can be observed that the stress-strain curve is characterized by three sections. The first section corresponds to the stress-strain curve before the concrete fails. In this section, the effect of the fiber wraps is minimal. The FRP wrapped concrete columns behave similar to those without FRP wraps. Immediately following the first part, a transition zone appears. In this section, the concrete is damaged gradually and continuously with the increase of the applied load. As the load increases, the concrete undergoes tensile cracking, mixed tensile cracking and compressive crushing until total crushing of the concrete. Figure 15 (a) – (c) show such a progressive damage and the associated stresses. In Fig.15, the circle represents cracking and the polygon represents crushing. It is noted that this section was not shown in previous studies by others. The reason may be that they used a wider range of strain (up to 0.02) so that this section (with strain range from 0.001 – 0.005) was undetected. Therefore, they failed to show the delicate details of this transition zone and claimed that it was a sharp turning point [20]. In this part, two opposite mechanisms are taking effect. On one hand, the concrete degrades gradually, resulting in continuous drop in stiffness; on the other hand, the FRP wraps are activated progressively due to the dilation and expansion of the confined concrete. Once the concrete is totally crushed, the FRP wraps are fully activated. This leads to the third section.

From Fig. 14, it is seen that, with perfect FRP/concrete interfacial bonding, the fiber orientation has a considerable effect on the stress-strain curve (solid lines in Fig. 14). As contrary to general assumptions that fibers should be aligned along the hoop direction, this analysis shows that it will be more effective if fibers are aligned along axial direction. This is understandable because, with perfect interfacial bonding, the FRP wraps are in biaxial stress conditions. The axial load applied to the core concrete will be transferred to the FRP wraps through the interfacial bonding. In addition, some of the load will be directly applied to the FRP wraps along the axial direction. Therefore, it is very likely that the axial direction is an orientation which needs particular care. The fibers should be aligned along the axial direction. With the weakness of the interfacial bonding, the axial load transferred to the FRP wraps becomes less and less. The difference between the axial direction fibers and hoop direction fibers will become less and less. If there is no interfacial bonding and no interfacial frictional force, the difference will almost disappear. This is exactly the case from the analysis. It is seen in Fig. 14 that, without interfacial bonding and interfacial frictional force, the stress-strain curves for different fiber orientations are almost overlapped (dashed line in Fig. 14). The effect of the fiber orientation can be neglected. It is noted that the interfacial bonding and the interfacial frictional forces cannot be zero in practice, thus the fiber orientation will always play a certain role. As shown in this study, fibers in axial direction will be more effective than fibers in hoop

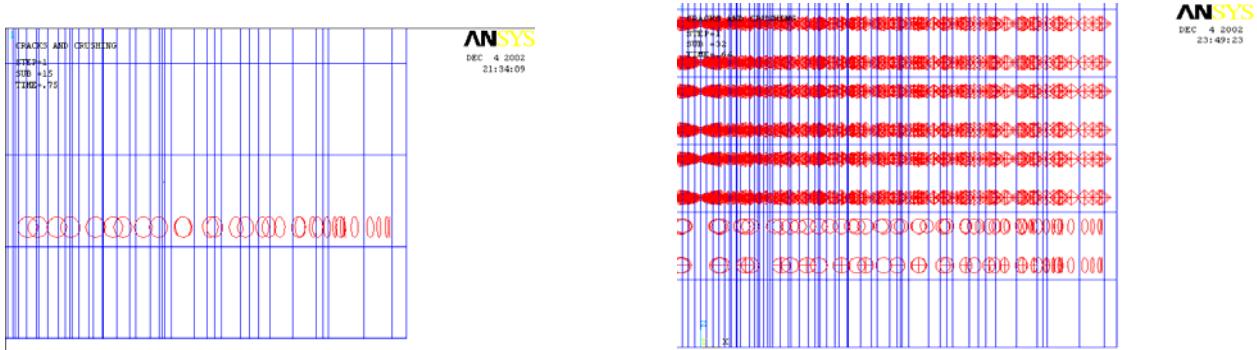
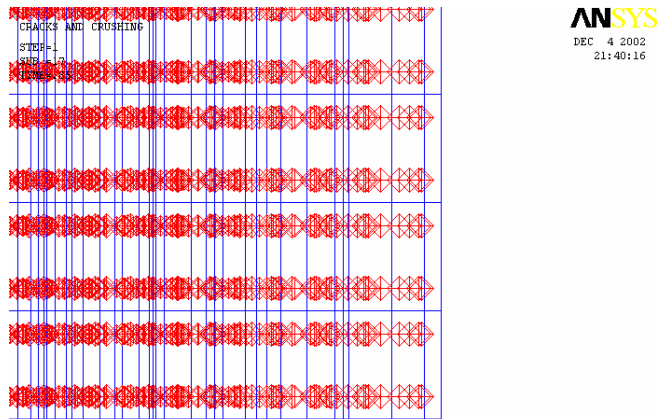
(a) Tensile crack at 35.2 MPa applied pressure (b) Mixed tensile crack and compressive crush at 38.7 MPa pressure

(c) Fully concrete crush at 42.0 MPa applied pressure

Fig. 15 Progressive damages in concrete
